February 27, 2018

08338 Version 2

2013–17 Accord: Judder from the Torque Converter Lock-Up Clutch After Software Update (Snapshot Upload Required)

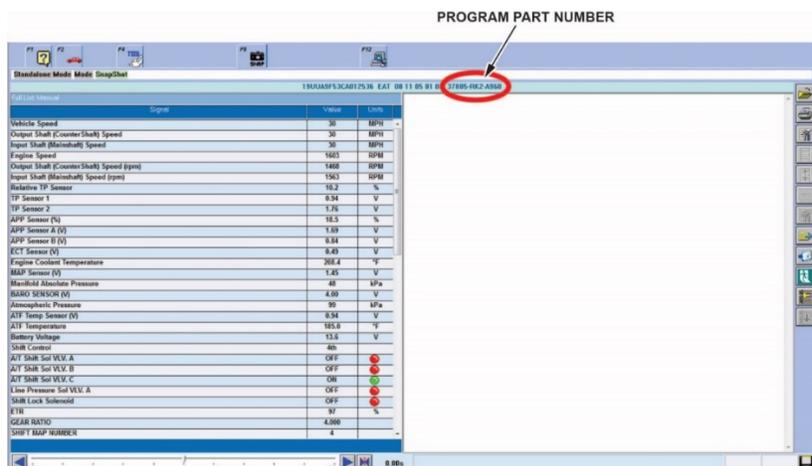
1. Connect the i-HDS, and go to the A/T Data List. Check to see if the software has been updated by comparing the program P/N against the table below.

- If the program P/N is listed below (or later), the vehicle has been updated. Go to step 2.

- If the program P/N is not listed, the vehicle has not been updated. Go to service bulletin 17-017 2013–17 *Accord: Judder from the Torque Converter Lock-Up Clutch After Software Update*.
2. Take an automatic transmission snapshot and forward it to Tech Line using the RO number. For more information about capturing and interpreting the data, refer to the job aid *Torque Converter Clutch Shudder and Vibration* and the *Tech2Tech®* video “Interpreting Torque Converter Judder Snapshot Data”.
 - If the snapshot indicates there is a judder, go to REPAIR PROCEDURE.
 - If the snapshot does not indicate a judder, this bulletin does not apply. Continue with normal troubleshooting.
- NOTE: **You do not need to contact Tech Line after sending the snapshot.** However, if you do not send a snapshot, your claim may be debited.
